Inspection Nightmares

InspekTech

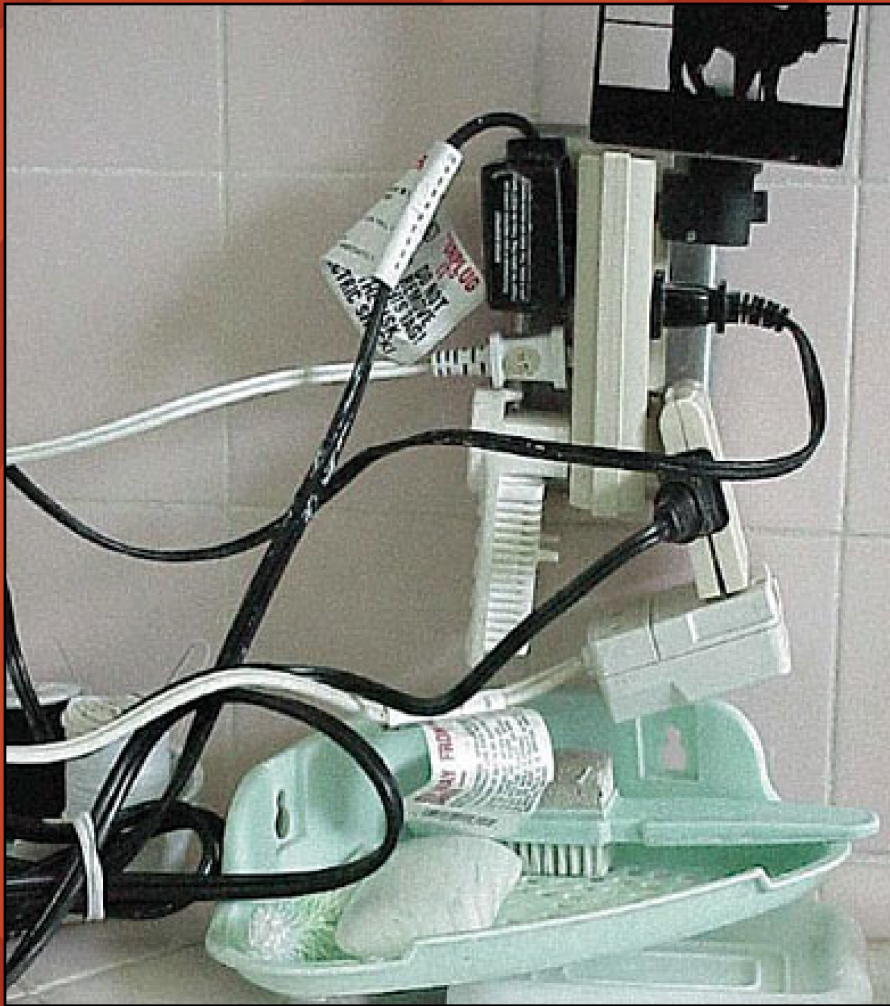
This bathroom outlet is not a GFCI. Thank providence, this homeowner had the presence of mind to leave all of the tags on, advising of potential shock hazard, should one carelessly remove the tags.

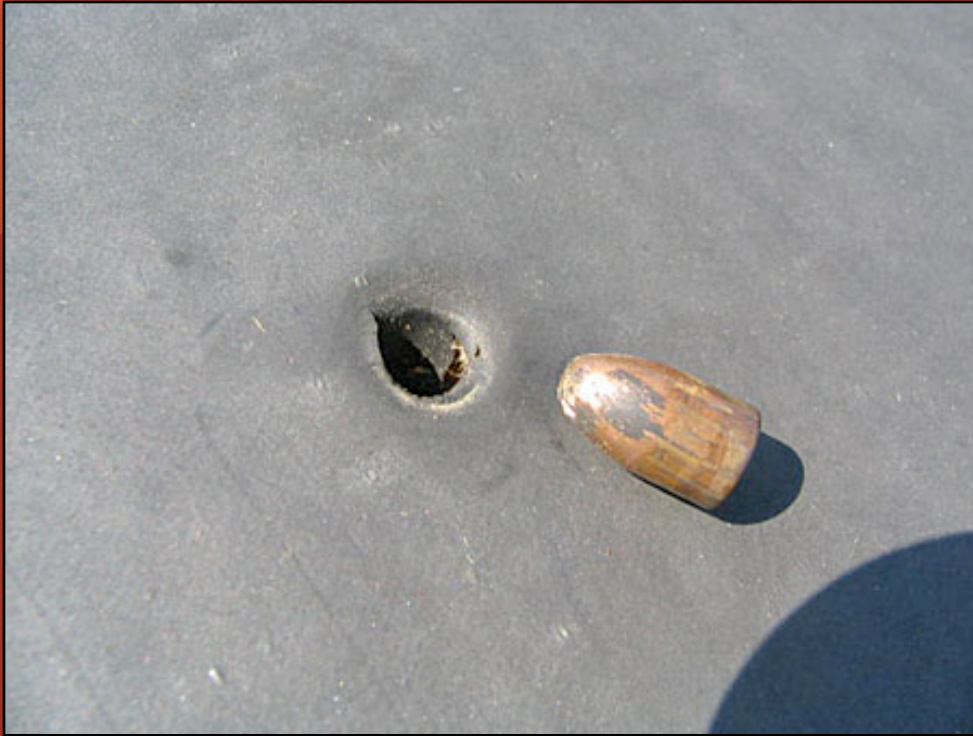
Q: What do you look for while inspecting a rubber roof?

A: Bullet holes, of course.

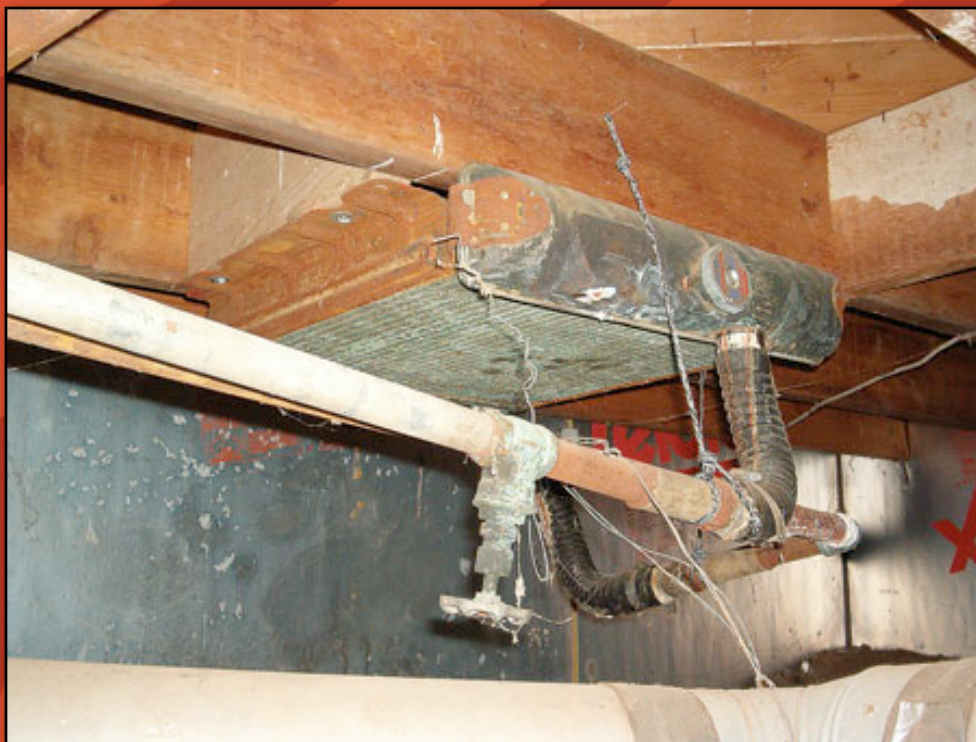
You're looking at some fine Ozark engineering. Yes, that is an automotive radiator attached to floor joists with hot water piped to it.

All the pipes and the wood-burning boiler were constructed of recycled components from who knows what. And this is only what I could see. The system never did function to their satisfaction. I wonder why?

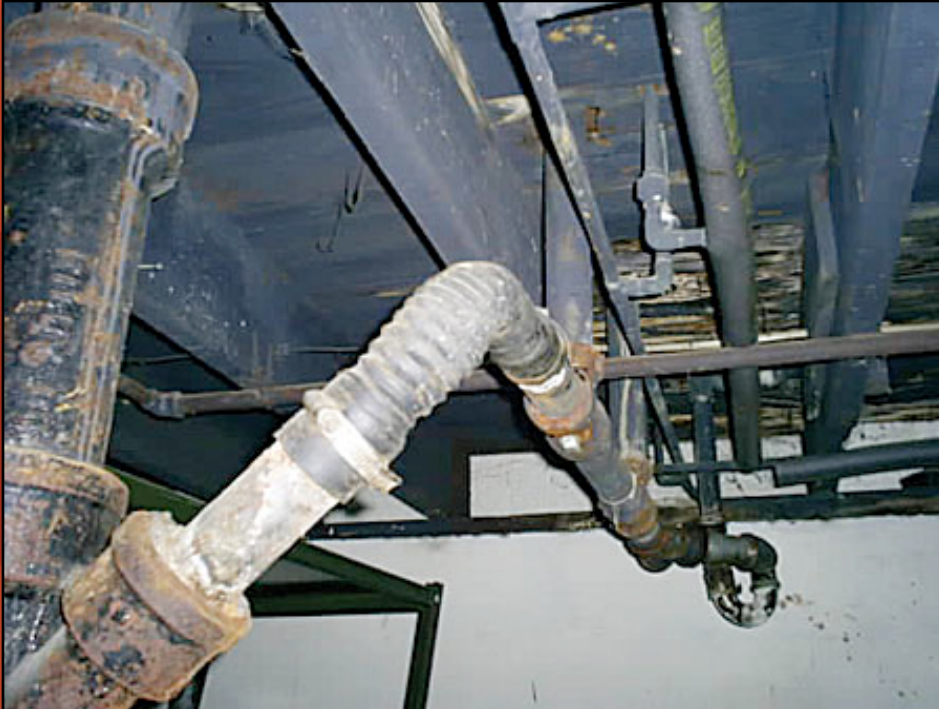
The work of an auto mechanic turned plumber? A radiator hose from a 1945 Pontiac was used to replace piping leading into the main drain stack.

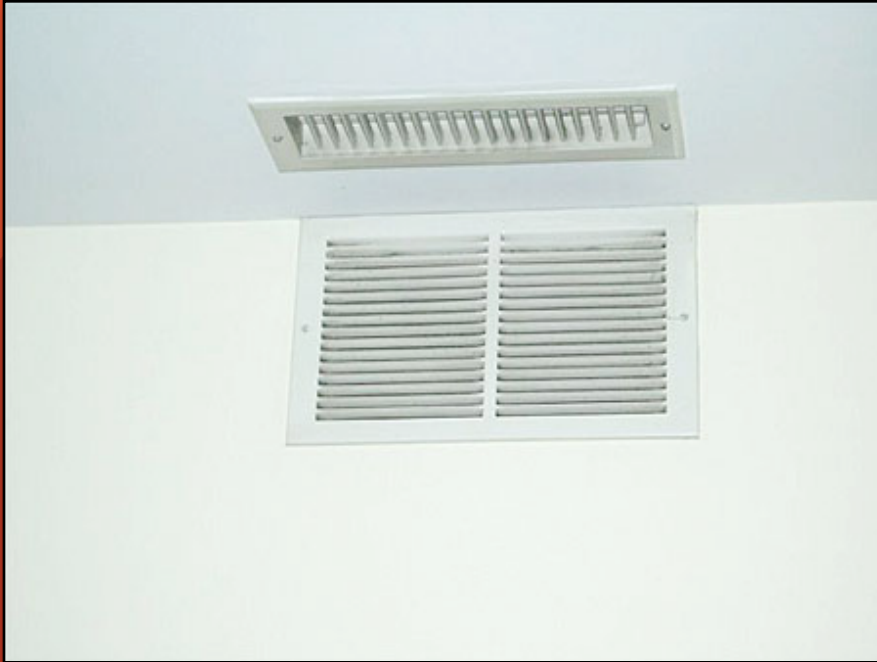
Here's another brilliant idea: Keep the supply & return registers close together so the hot air can flow freely back to the furnace.

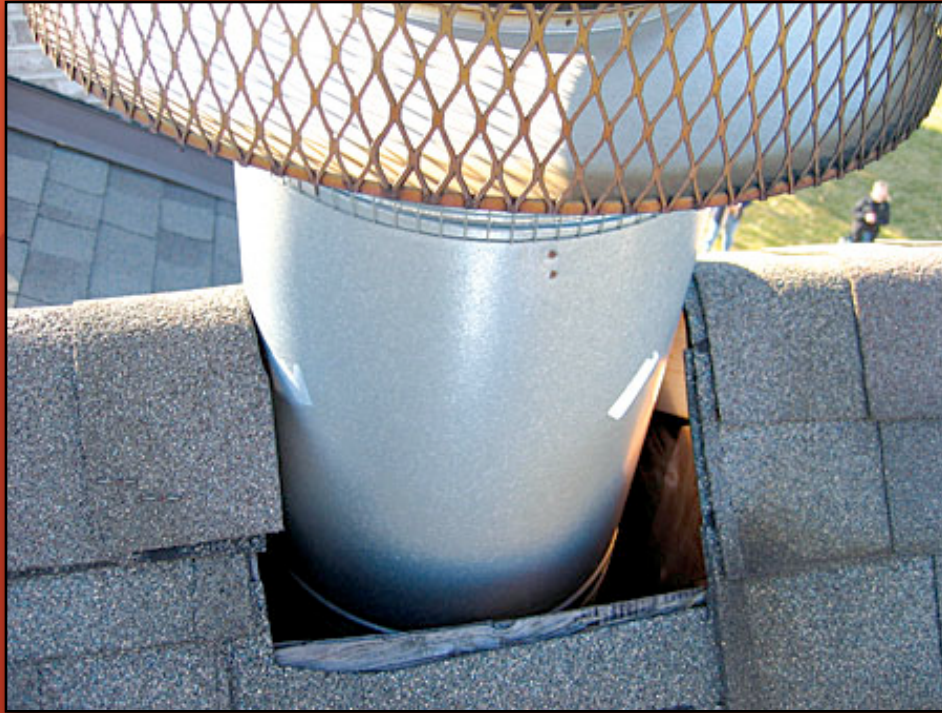
Flashing—who needs flashing?!

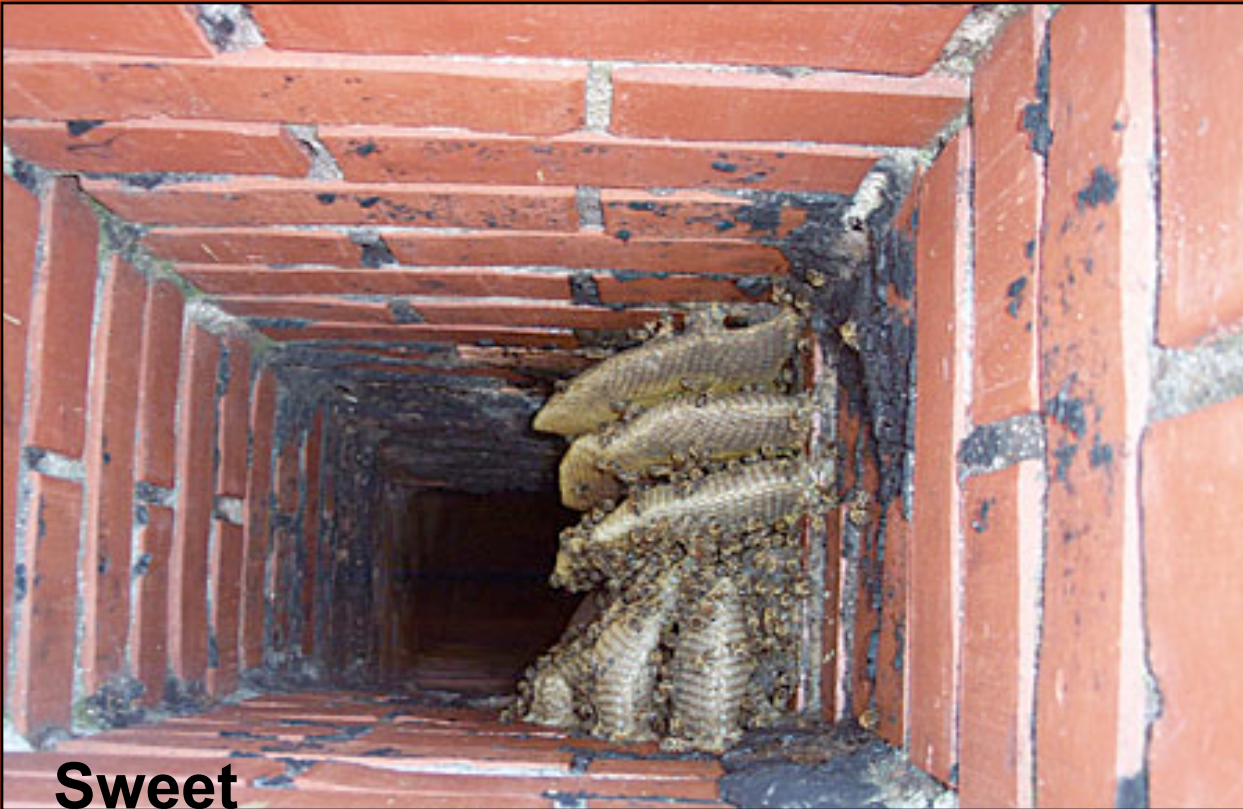
"Bee" careful when looking down chimneys, especially on an old two-story farm house with a steep pitched roof. It was quite a surprise to find honeybees. Usually, we encounter wasps, hornets, raccoons, etc.

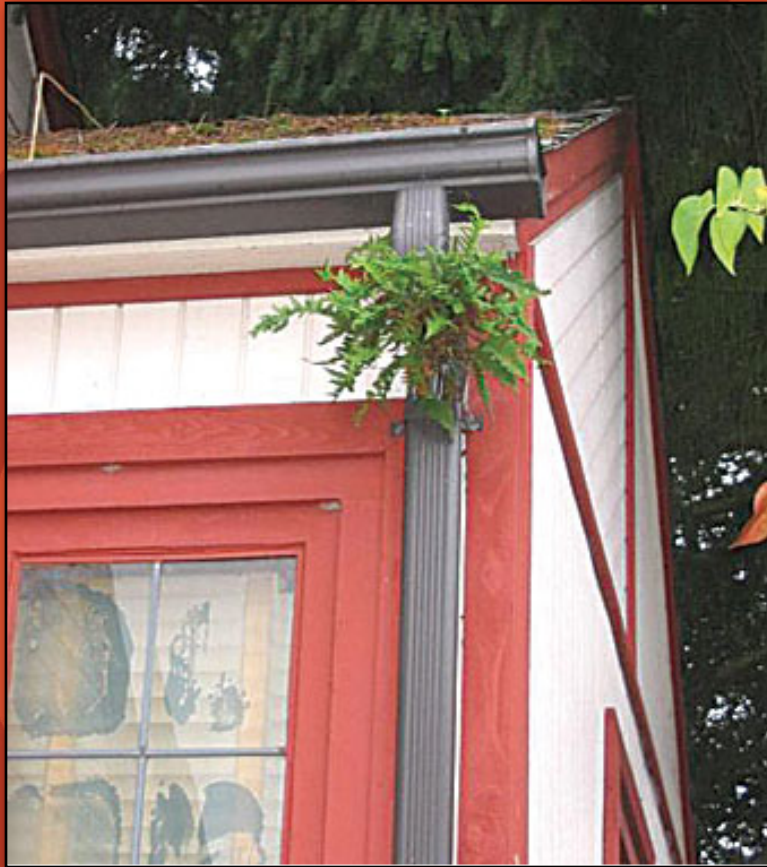
Here you have your basic downspout planter, with an attractive—and healthy—sword fern contrasting nicely with the red window trim. You too can have one of these beautiful planters. Just don't clean your gutters for five years.

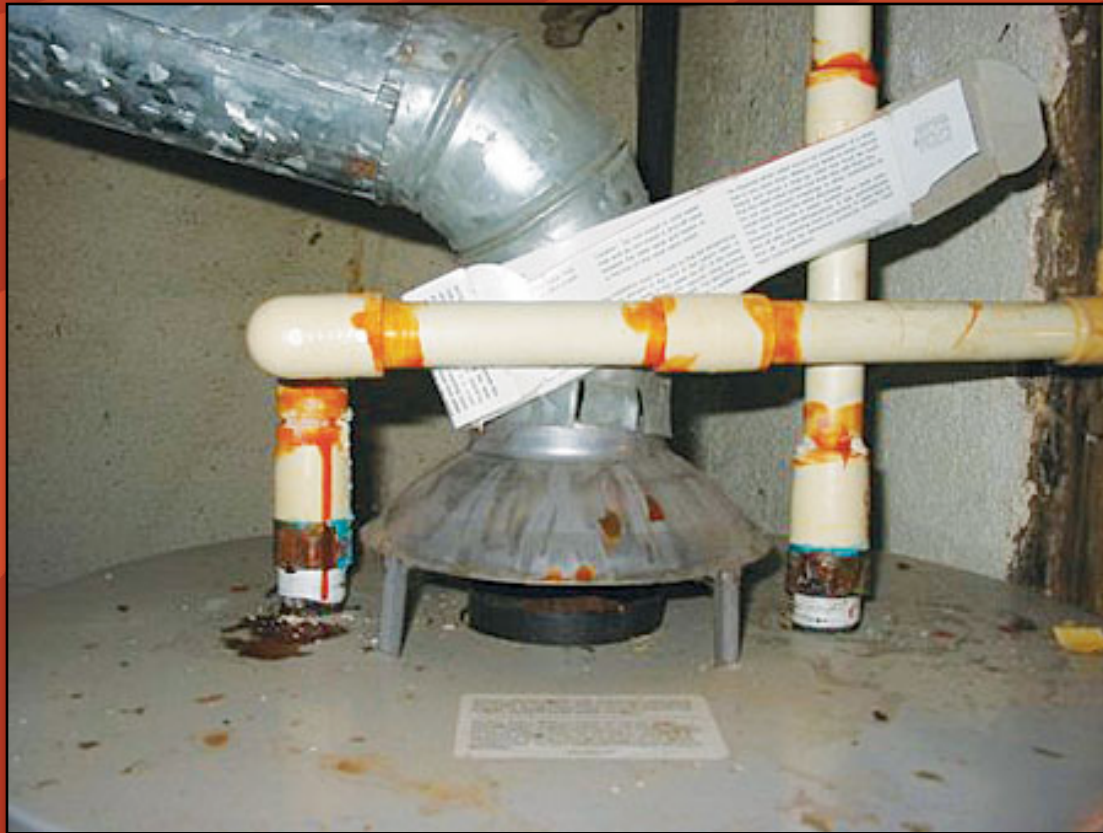
Harry Homeowner installed this CPVC pipe touching the flue pipe. The fix? Slip some cardboard between the warm flue pipe and meltable plastic! The good news? The gas was turned off and I recommended repairs by a licensed plumber before re-inspection.

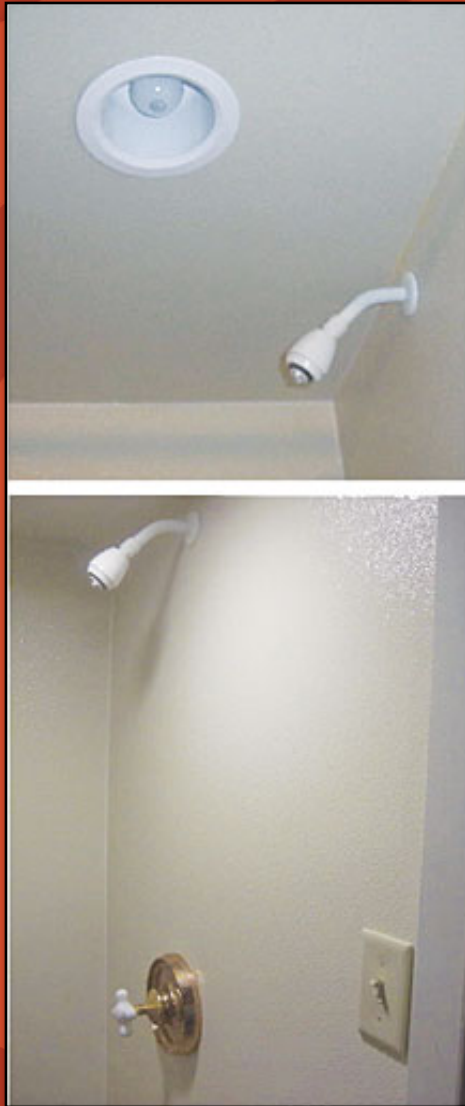
The top photo shows an **unprotected light bulb** in a **homeowner-constructed shower** in the basement of a home I inspected. As if that wasn't bad enough, the second photo shows that in that same bathroom, he located a switch **INSIDE** the **shower stall!**

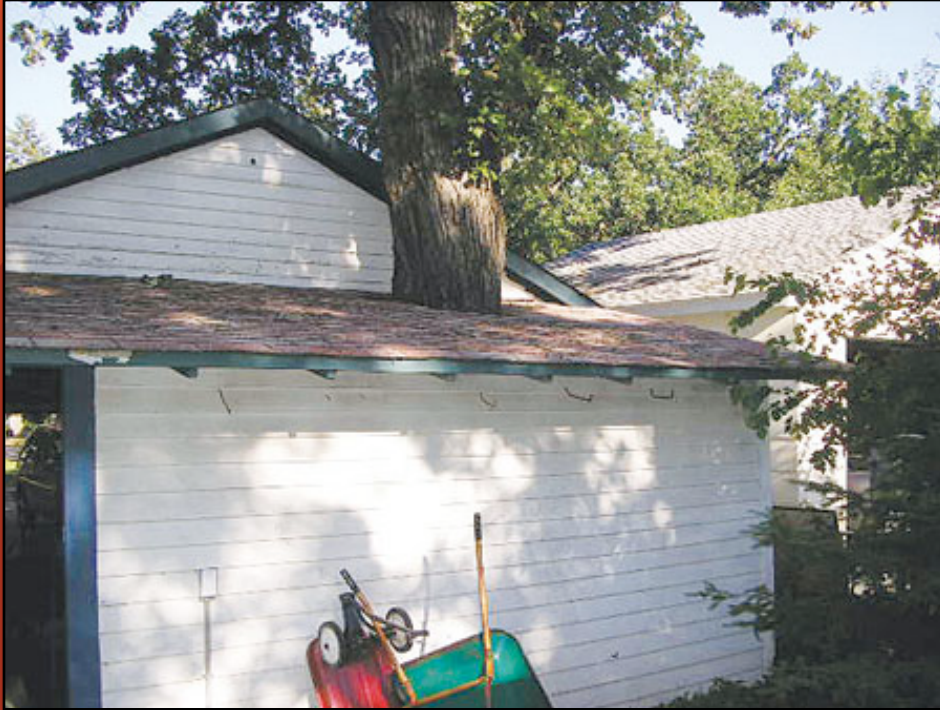
What does the
Standards of
Practice say about
"tree houses"?

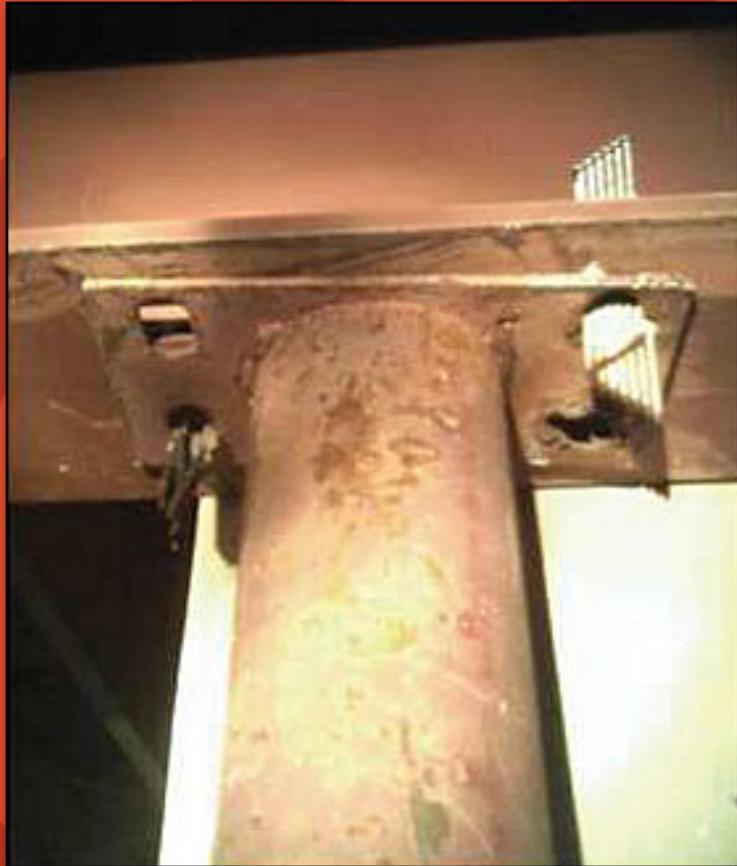
How to secure the column to the I-beam that supports the floor? "Well, if we can't find the bolts or the welder, just stick some nails in there." I can't imagine any other explanation for this find in a one-year-old home.

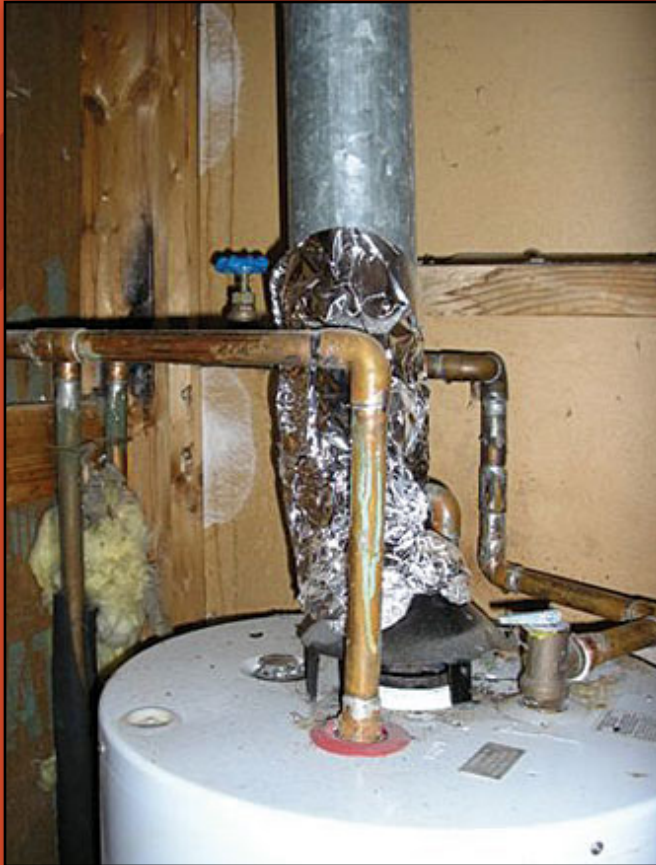
**This section of
water heater flue
pipe is made
entirely out of
aluminum foil!**

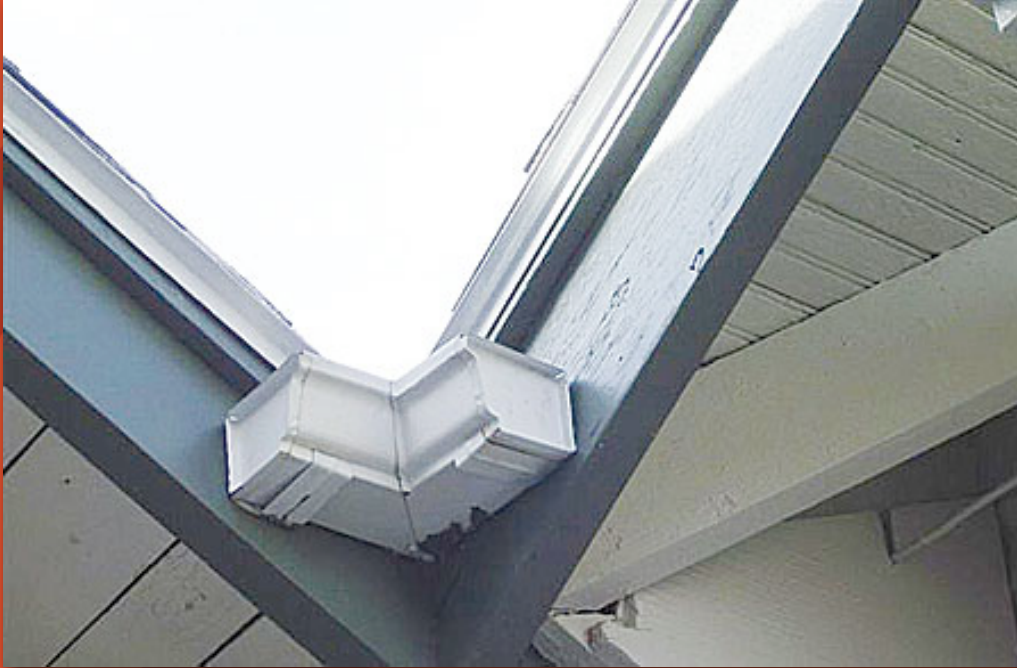
**I found this rain gutter capped on both ends.
I wasn't surprised to find decayed material
inside.**

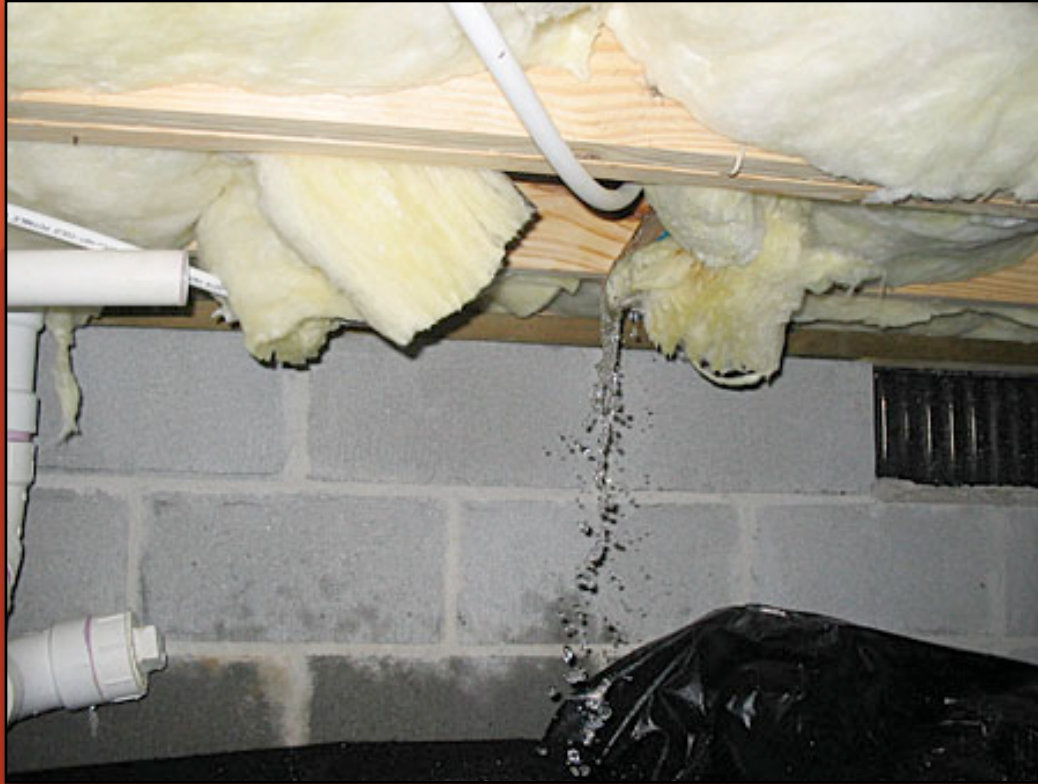
I captured this photo in the crawl space of a new-construction home after it had passed all municipal inspections. The **bathtub drain was never completed.**

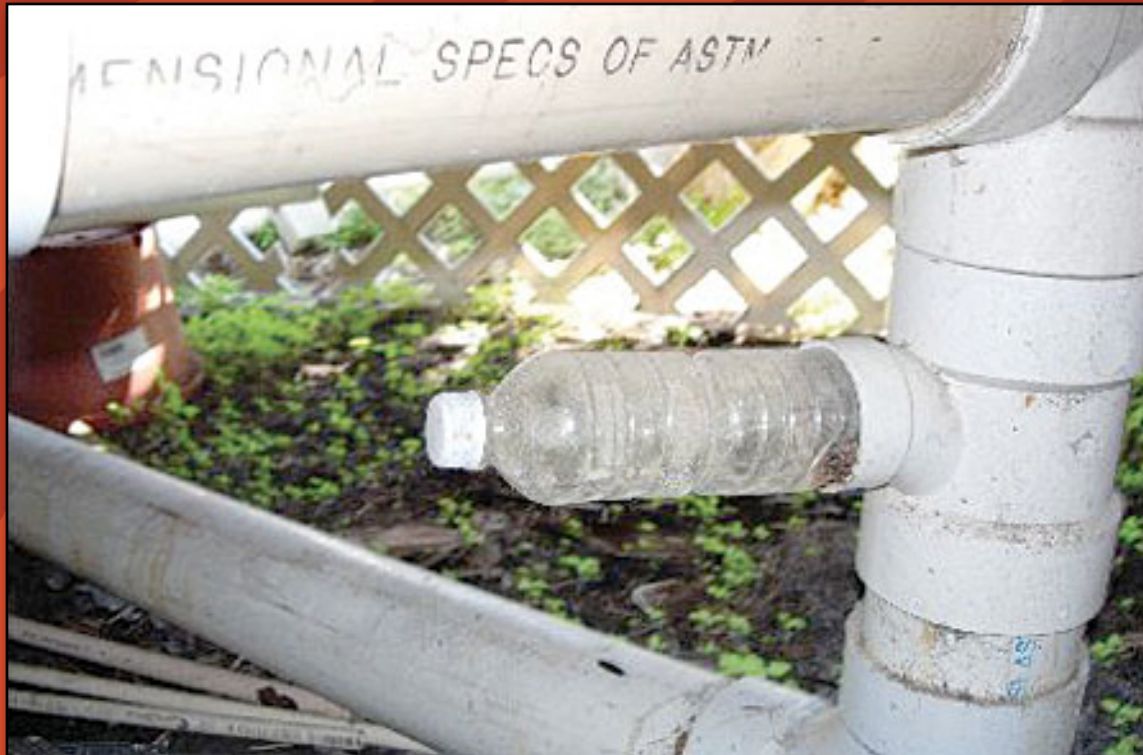
I found this on a recent inspection. When the toilet was flushed, water and whatever spurted out around this bottle.

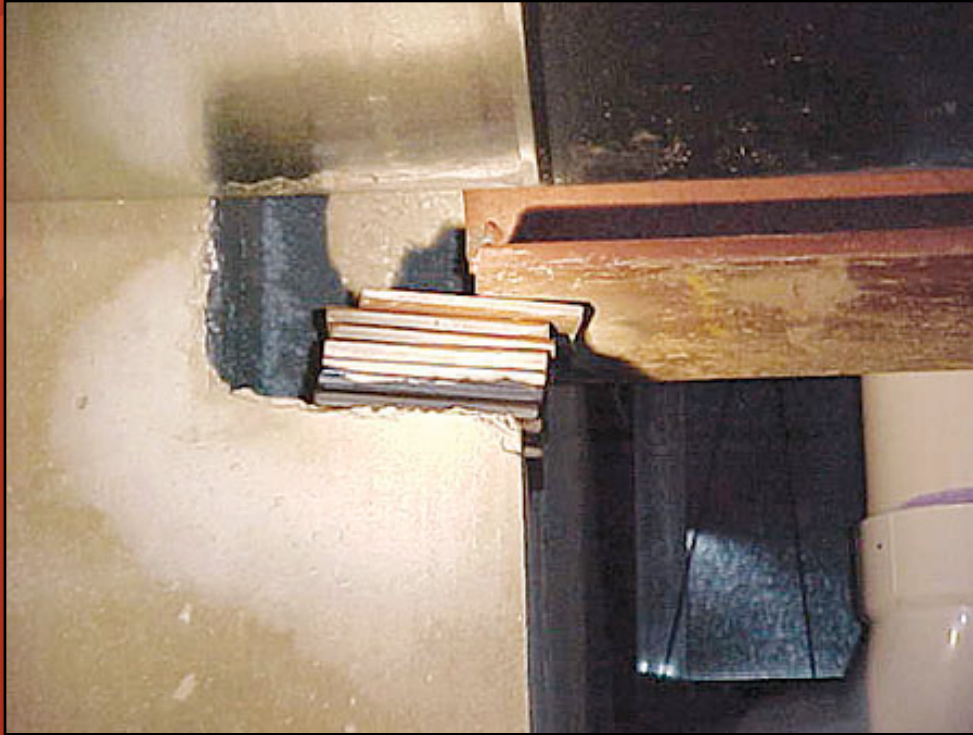
Another I-beam fiasco. I hope there is never an earthquake near this house!!

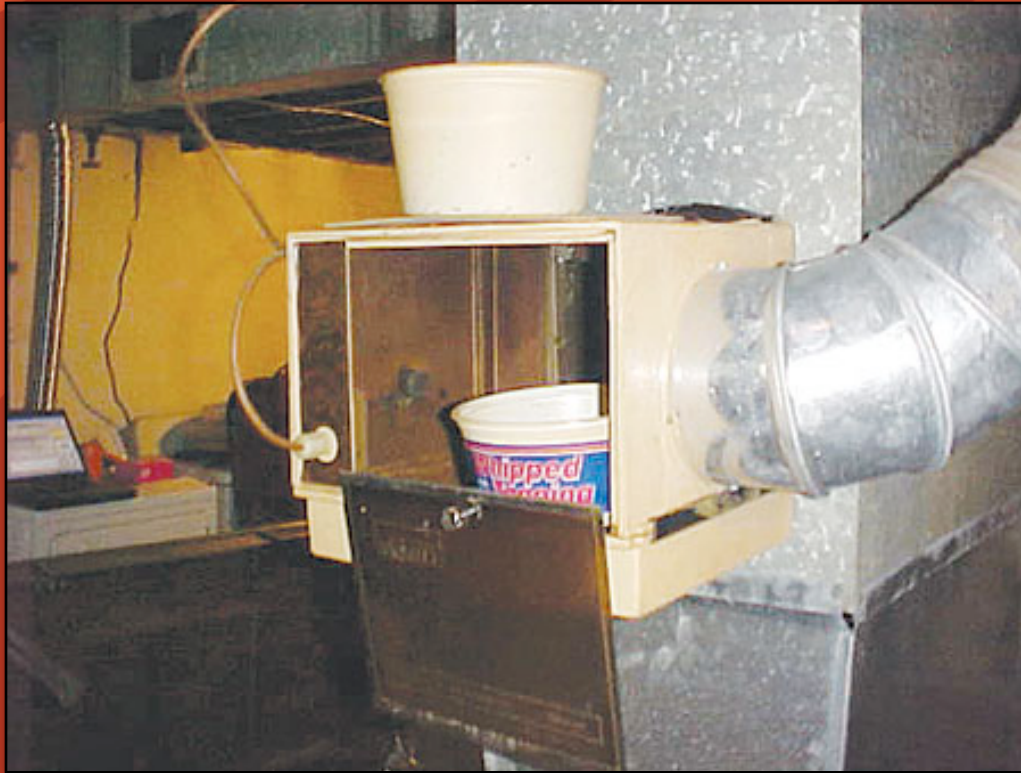
Saw this at an inspection today, and it was good for a chuckle. Apparently, the homeowner didn't want to mess with all that high-tech gadgetry in a humidifier, so he replaced it with a Cool Whip container filled with water! (Not Cool!)

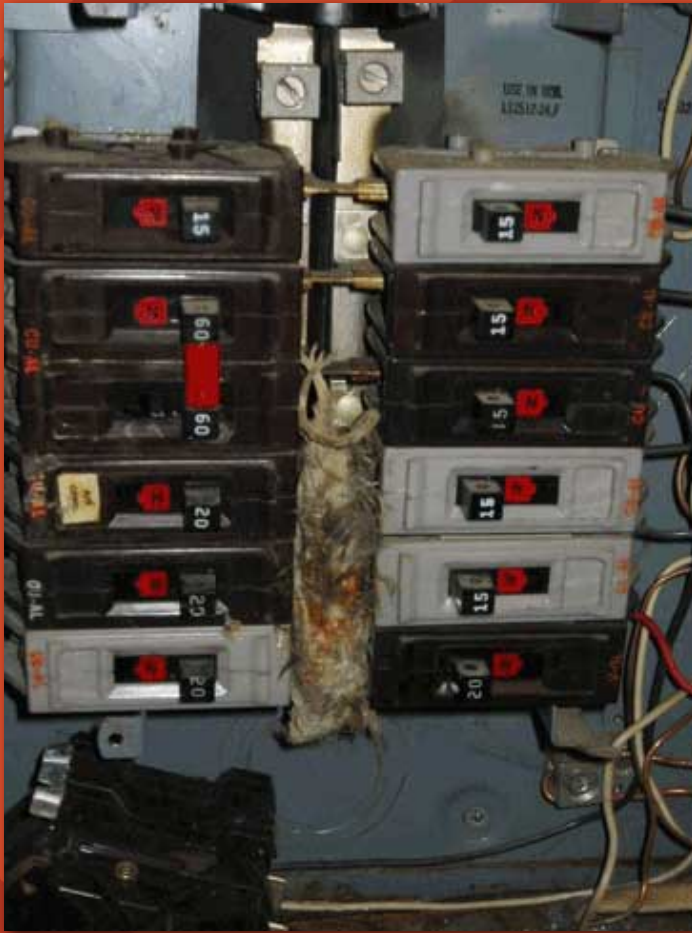
This is a photograph of a rat that entered an electrical panel through an open knockout. When it came in contact with the grounded box, it got fried! I show this picture, which I carry to all inspections, to homeowners who pooh-pooh my complaint of open knock-outs at electrical panels.

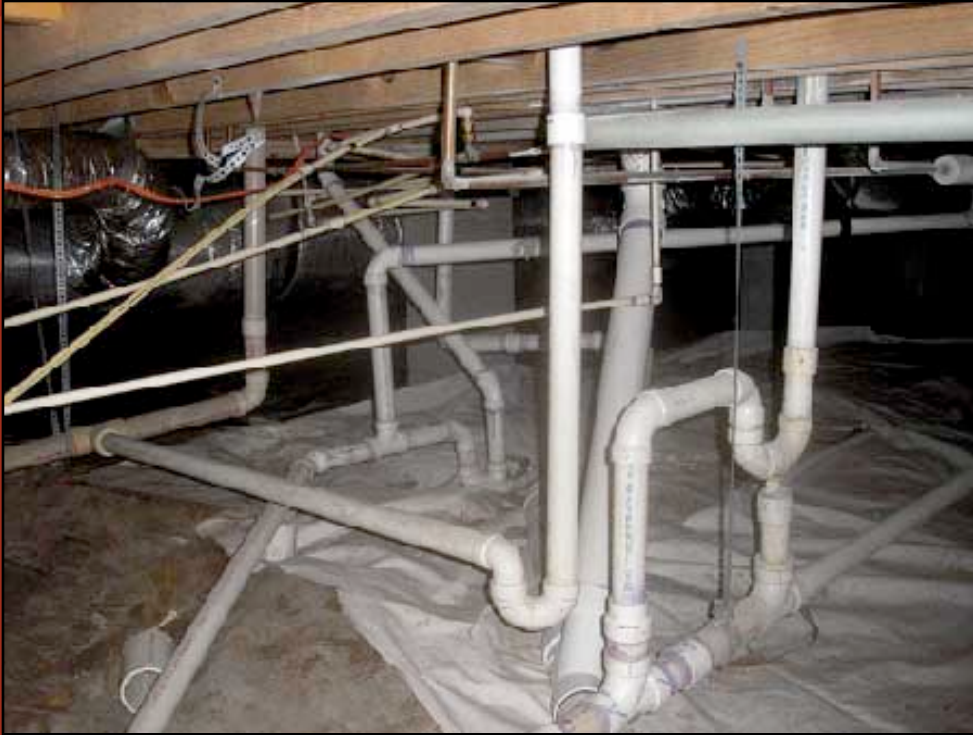
Wasn't there a screen saver like this? This is a picture of some amateur plumbing work for the drain system of a home.

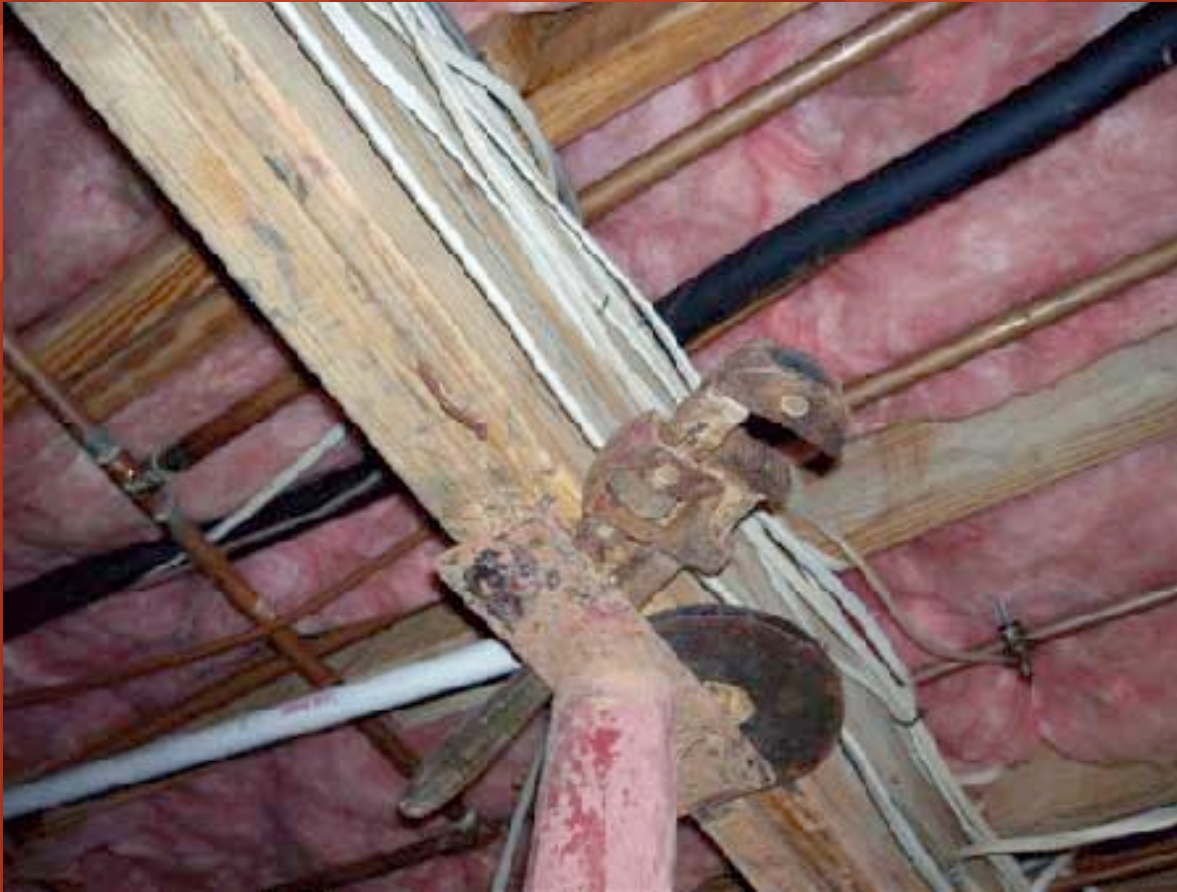
Generally, a solid shim block or steel plate is used between a support column and girder. When not available, is it ok to use a **rusty old pipe wrench and weightlifter's plate?**

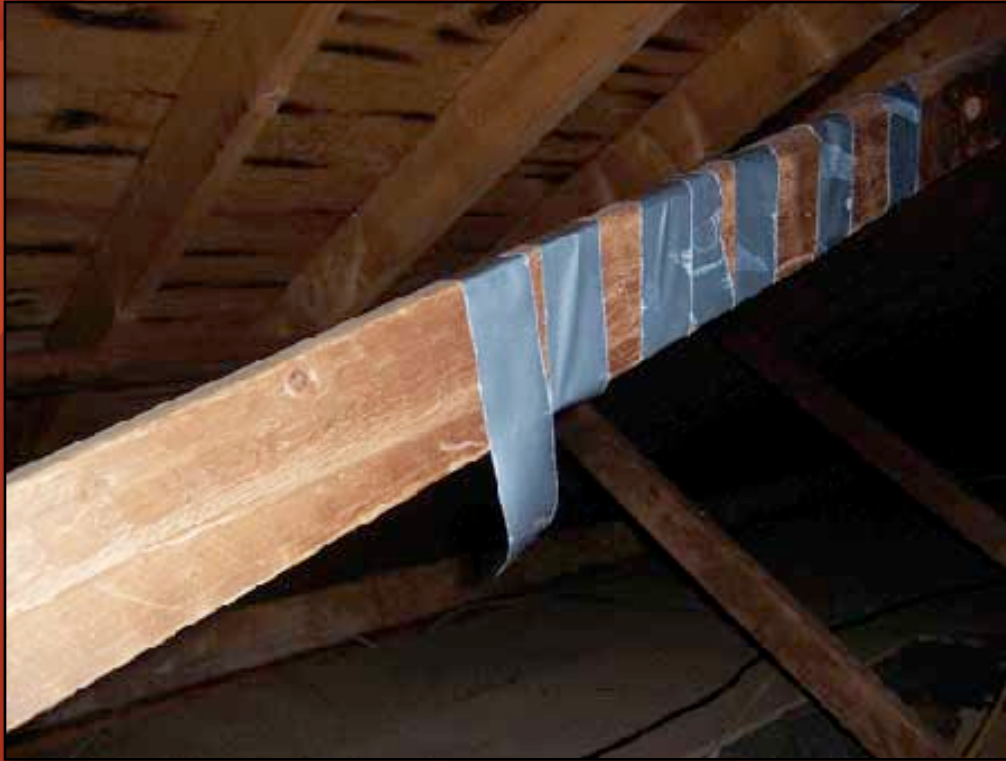
If you have a broken framing member in your attic, use the all-purpose structural repair kit — **duct tape!**

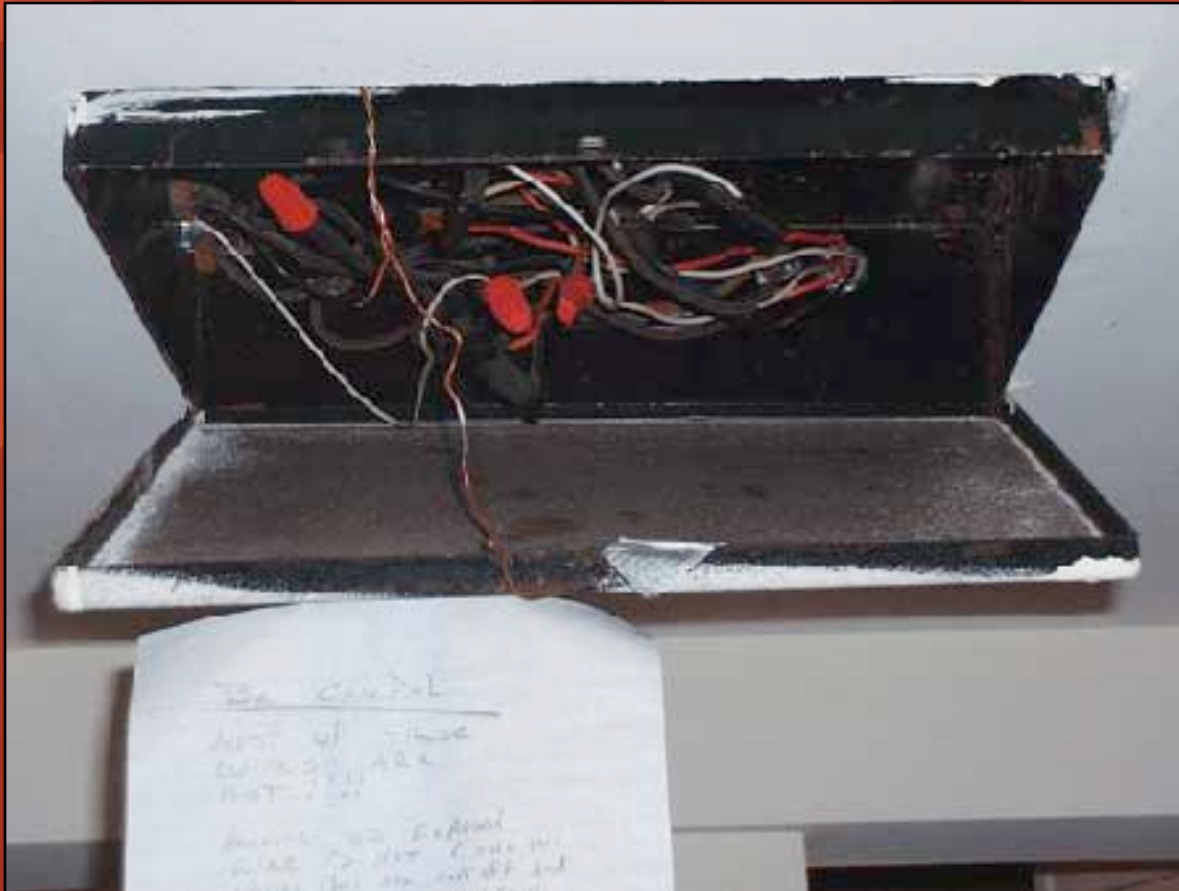
I guess we would call it a 1921 oversized junction box (1' x 1.5')! Someone left a note attached indicating some of the wires were hot!! This 'box' was located on the basement ceiling and open when I found it!

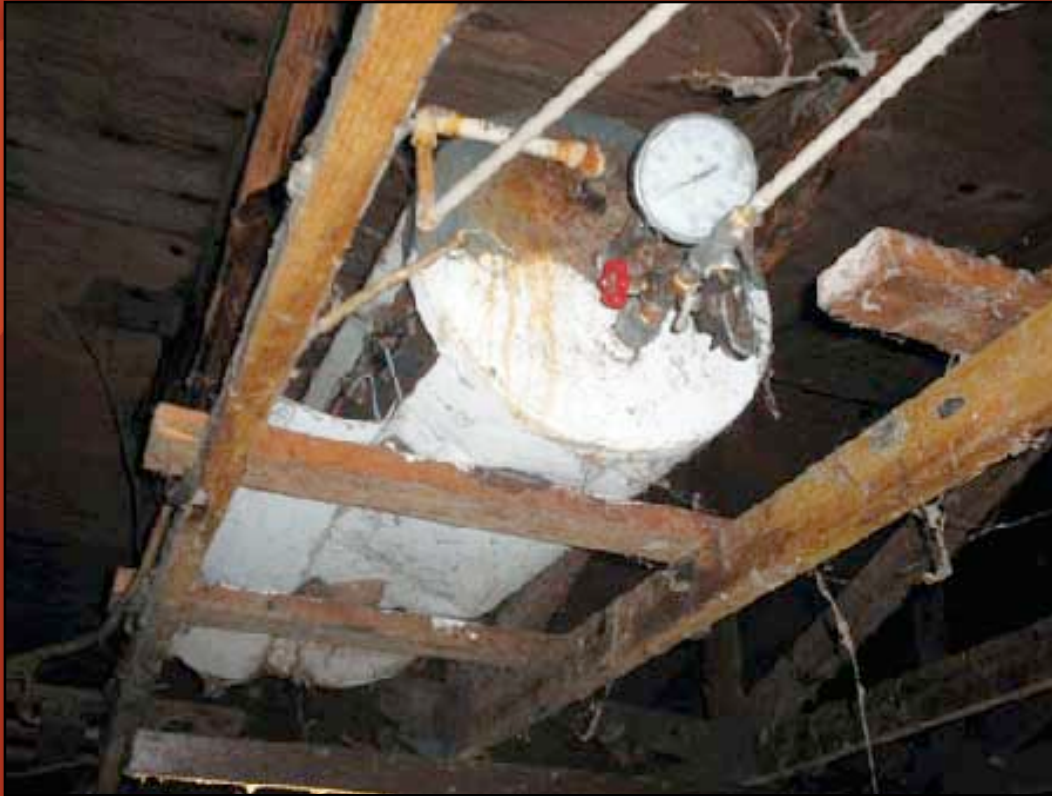
Not only did the homeowners install the water heater on its side, but they replaced the TPR valve with a large pressure gauge. Fortunately, the house was vacant and the heater not pressurized at time of inspection.

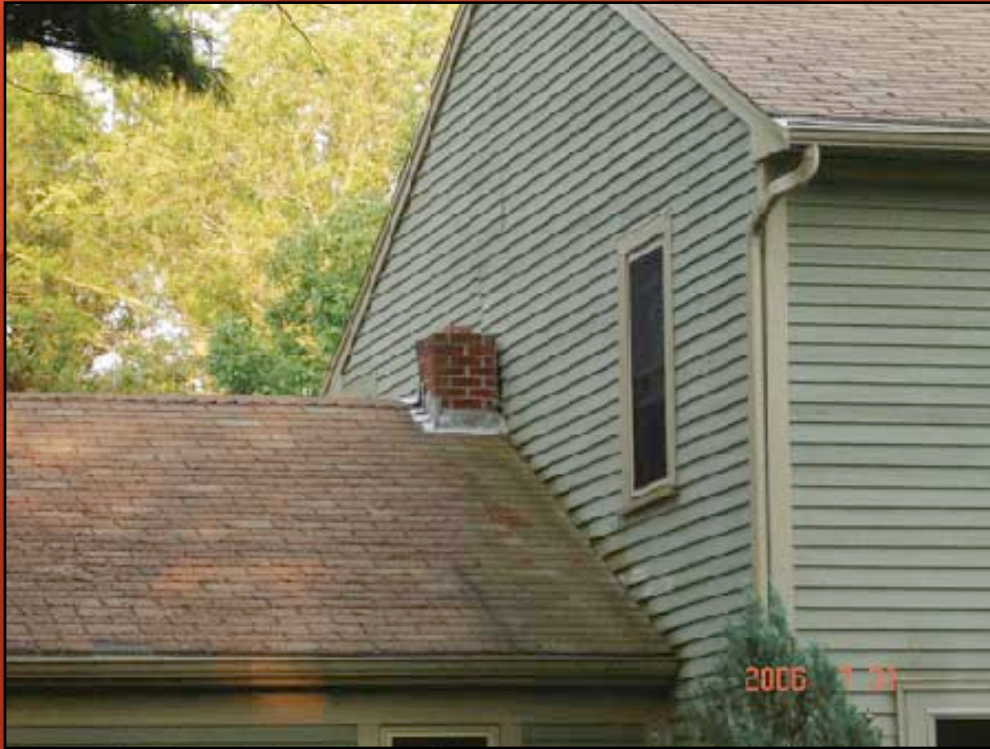
I had to stop while driving by a home to take this picture of a chimney.

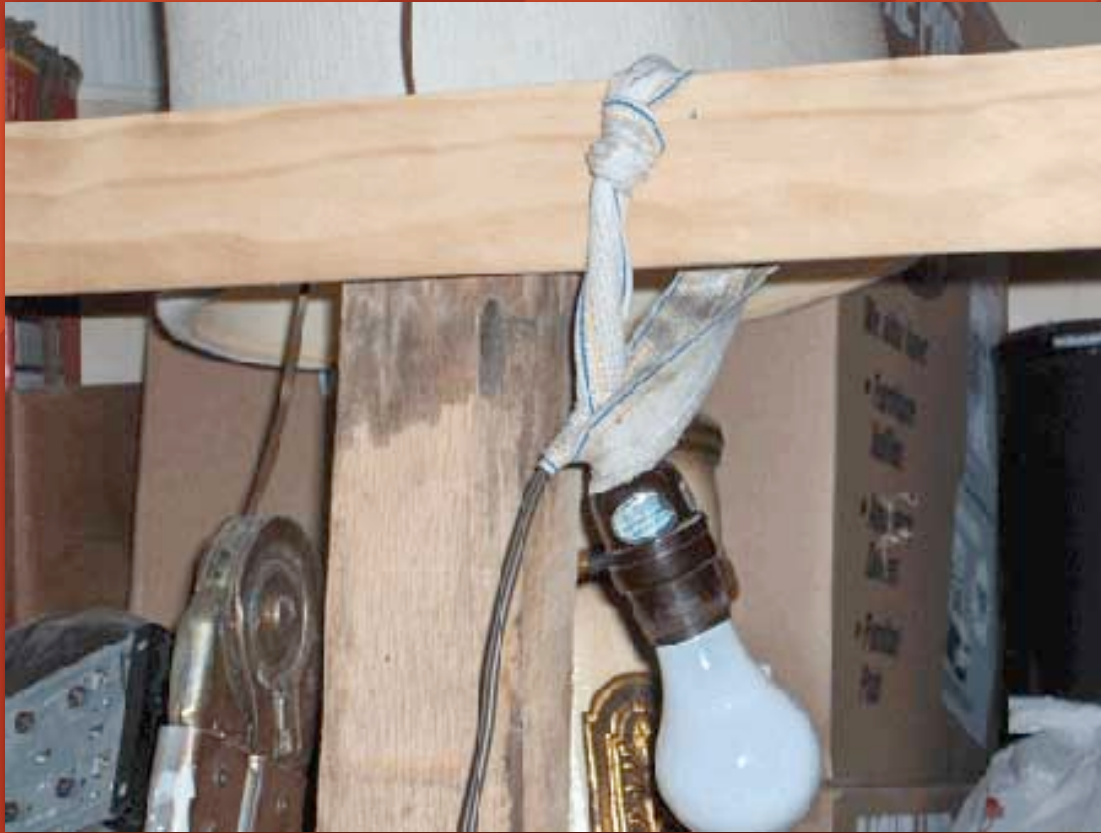
The homeowner thought: "I knew I could find a use for that old jockstrap someday."

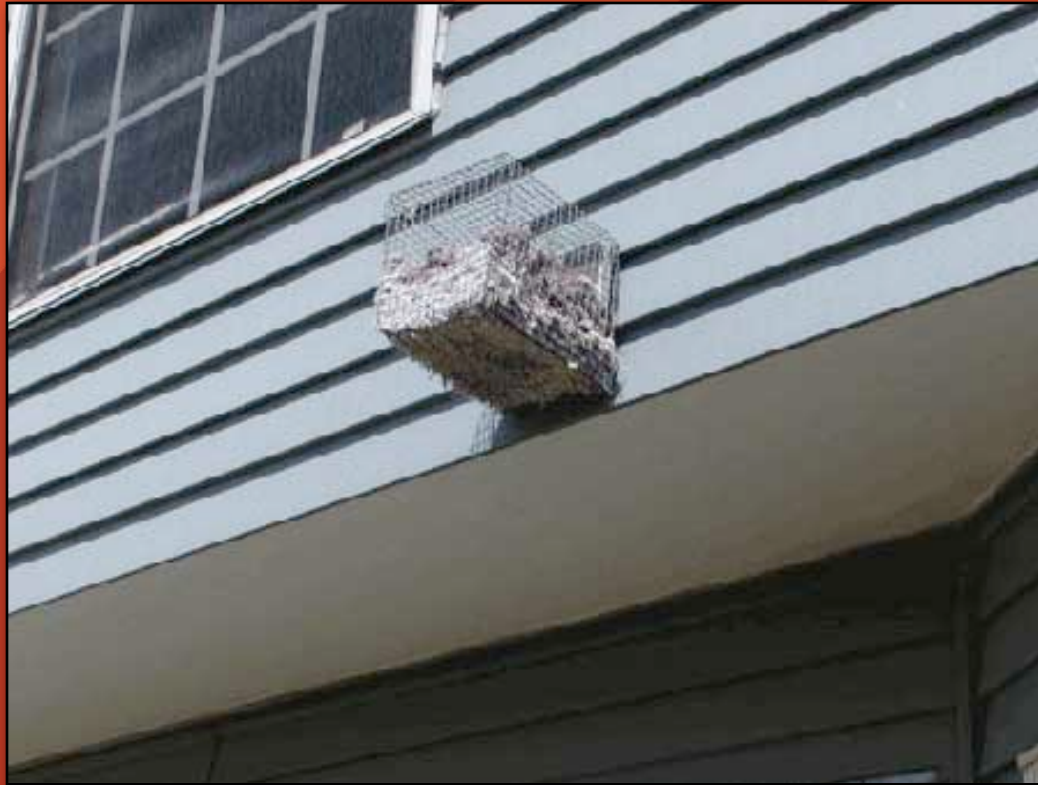
Here is a photo of a dryer vent showing why they're not supposed to be screened. I've heard of saving your pocket change for a rainy day, but saving the pocket lint? This was someone's idea to keep out the birds; it took quite a bit of work to make it this nice.

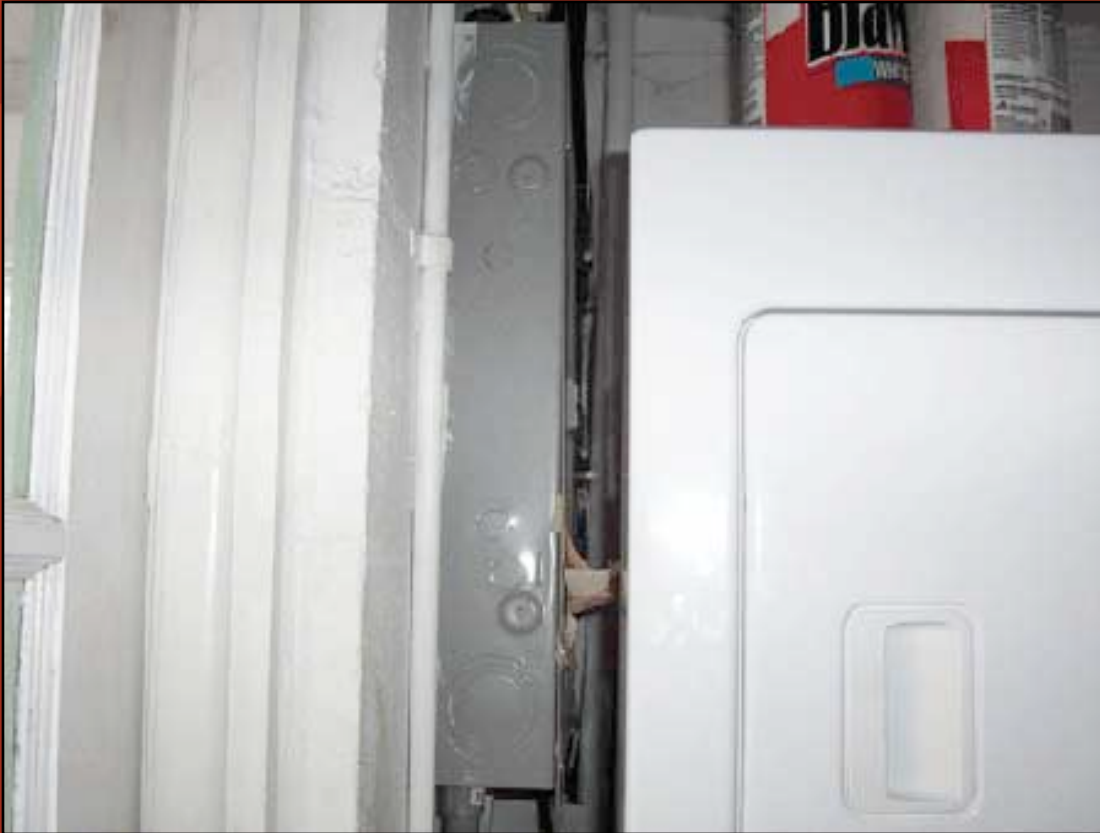
This is a picture of an electrical panel with an apartment-size washer/dryer combo sitting right in front of it. Hope the owners don't have to get into it in a hurry in case of an emergency.
