Inspection Nightmares

InspekTech

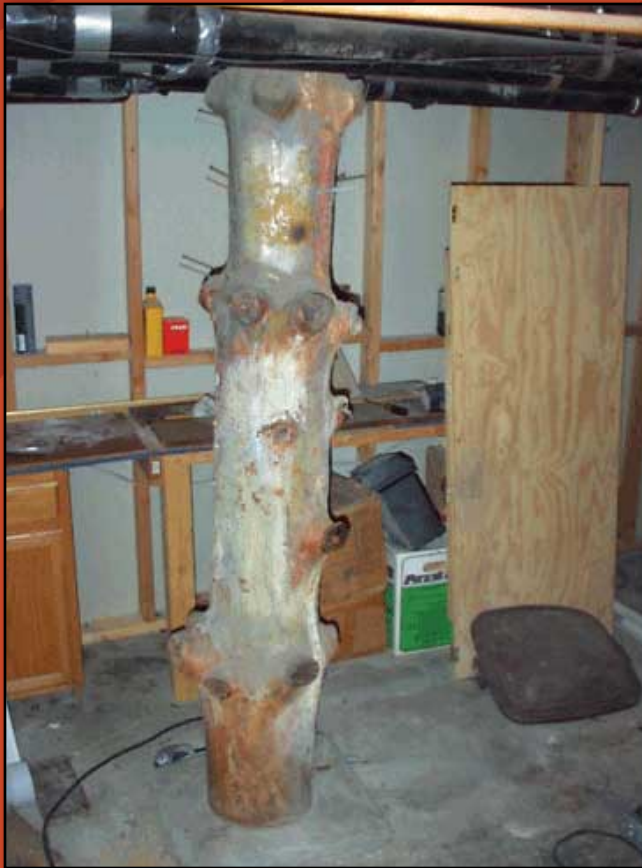
I found this tree,
used as structural
support, at a recent
inspection.

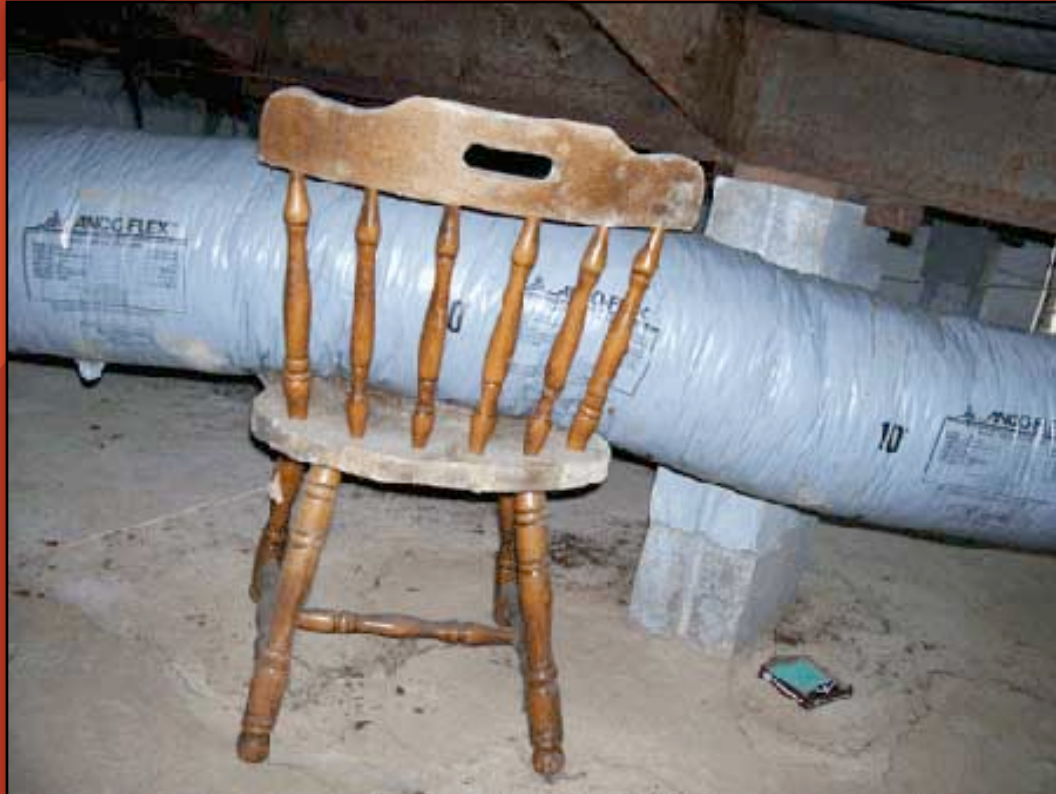
Have a seat and tell
me about proper
flex duct support.

I found this in the
crawlspace of a
manufactured
home.

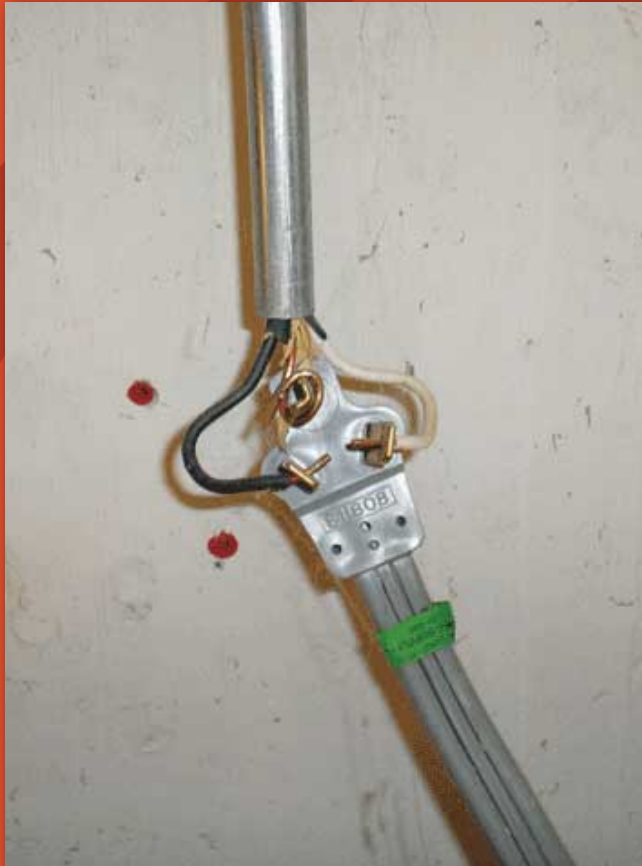
Here is the latest in electrical wiring techniques for dryer hookups. I guess he ran out of electrical tape in the middle of this project. My guess is that the homeowner turned off the breaker before connecting this.

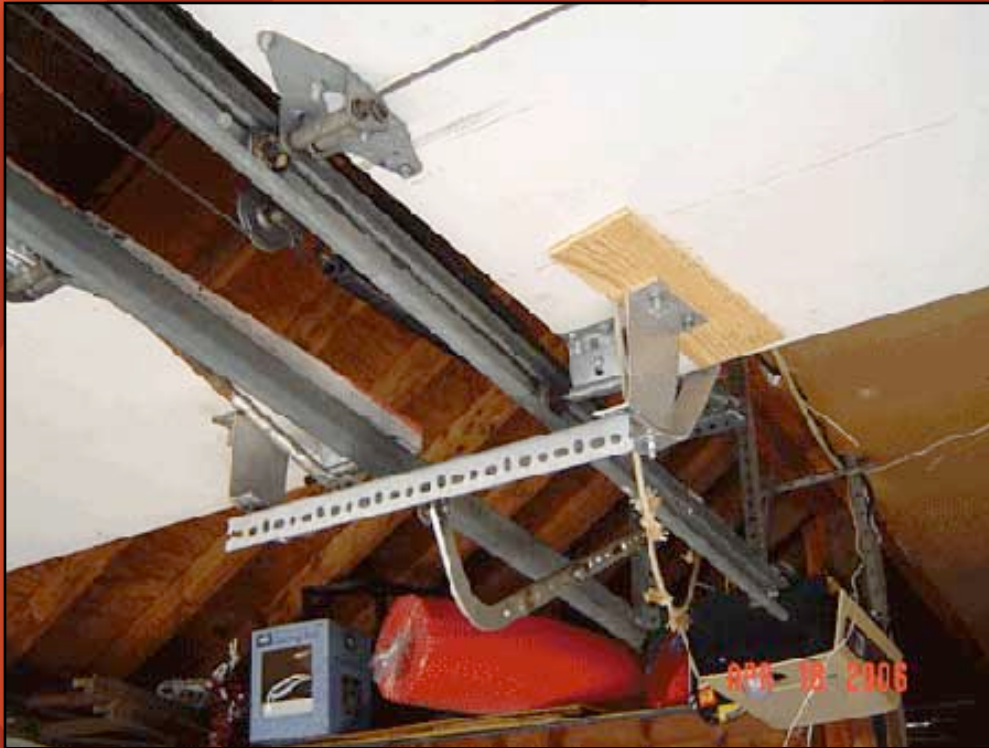
The homeowner of this house apparently did not want to buy two garage door openers and installed one in the center of the two doors and connected them.

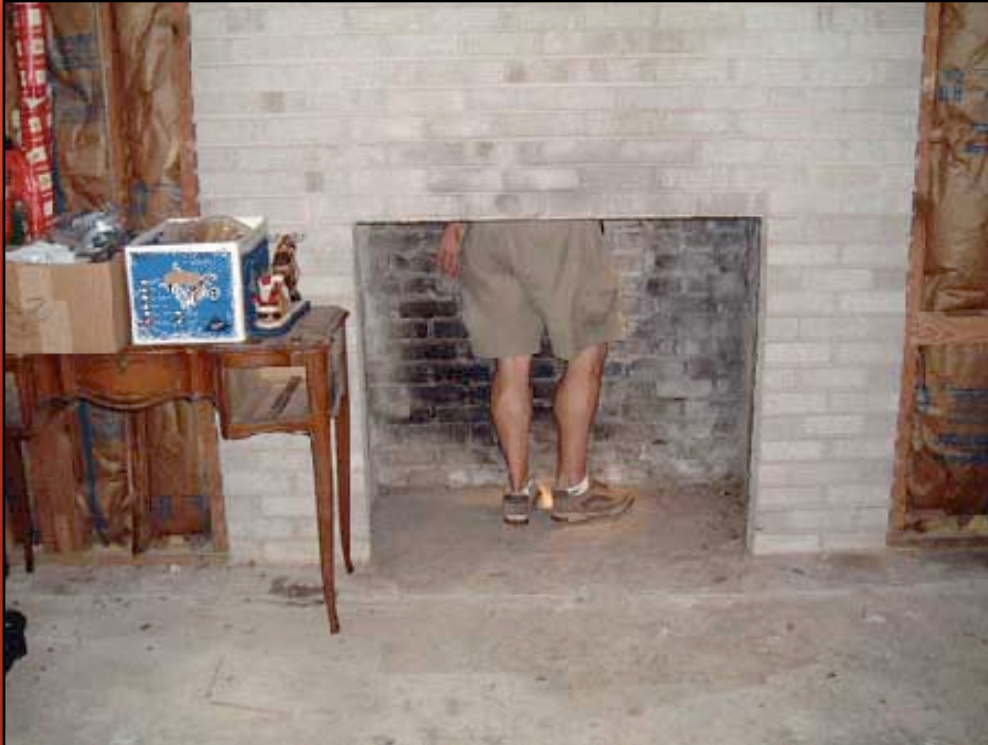
Some fireplaces are easier to inspect than others...
